Nondestructive Evaluation (NDE) Capabilities Data Book

Nondestructive Testing IAC

Nondestructive Evaluation (NDE) Capabilities Data Book (continued)

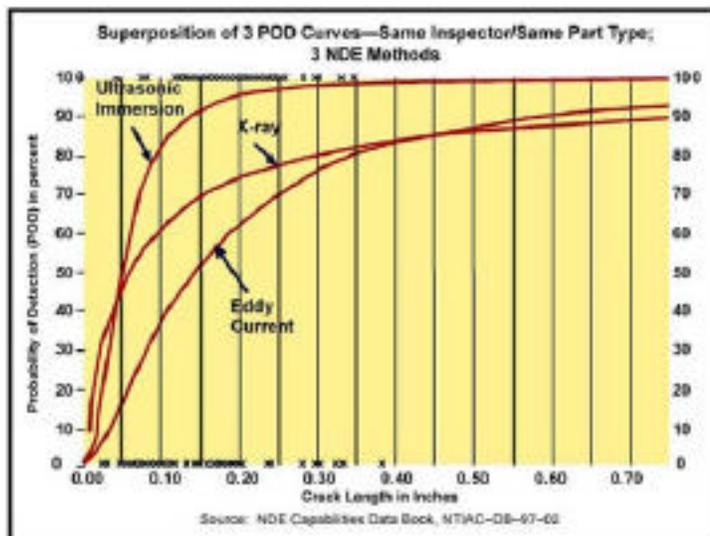
To provide assistance in the nondestructive inspection of aging aircraft, NTIAC compiled an *NDE Capabilities Data Book*, which consolidates available POD reference information into a single source. Over 400 POD curves are organized by NDE method for varying inspection scenarios and data collection conditions. The *NDE Capabilities Data Book* provides guidelines for selecting options for use of nondestructive inspection for various crack detection requirements. The Data Book is available from NTIAC in both hard copy format and on CD. An example of POD curves from the Data Book is given below for crack detection in Titanium alloy plate.

In addition to hidden corrosion, widespread fatigue damage is a primary threat to aging aircraft. Reliably detecting and characterizing cracks associated with fatigue damage is an important challenge to inspectors of aging aircraft. A frequently used measure of the reliability of a nondestructive inspection method is the Probability of Detection (POD) which gives the probability of detecting cracks of various lengths and depths under various inspection conditions.
